# A.H. WORK IN PROGRESS Autumn 2025

Once again the time has come to provide an update on progress with *Normandy*, the Adams B4 class 0-4-0 Tank locomotive.

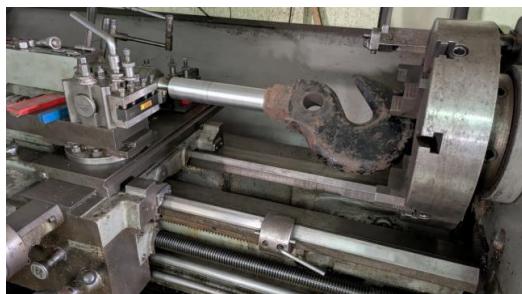
To start with, we found the rear coupling hook was worn down to an excessive amount and was in such a condition that it needed replacing. Building up with weld is a procedure that is totally unacceptable on such a stressed and safety critical component but a rummage in our storage came out with one that was in virtually new condition, but was about 3 feet longer than we needed. Our horizontal band saw sorted that bit, out but then it needed threading to take the retaining nut, plus the square shank was a little too large. It was mounted in the lathe and Malcolm carefully screw-cut the thread. After that he also made a new nut to suit. (Fig 1 & 2).

Fig 1. Shortened coupling hook ready for screw cutting

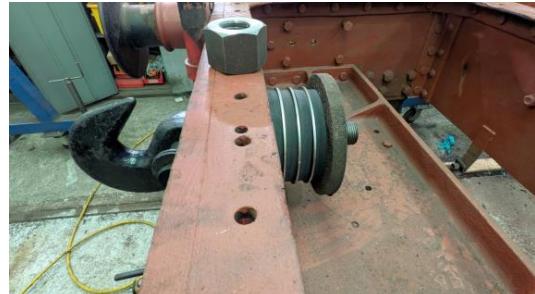
Fig 2. Reworked coupling hook being trial fitted  
New nut can be seen on top of the framing

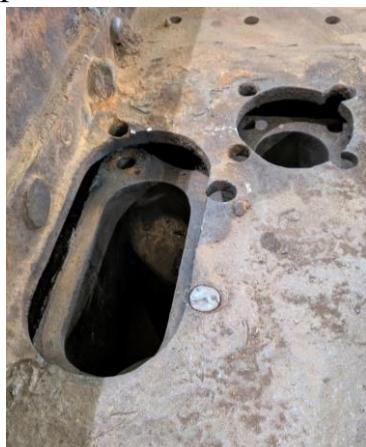
At this time, while the chassis was still on its wheels the cut off studs that were used to hold the main steam pipes and also the exhaust pipes to the valve chests were tackled. Keith Sturt's many years of experience together with bucket loads of perseverance and patience allowed him to remove all of these studs without damaging the threads in the cylinders. The holes in the valve chests into which those studs were screwed resides underneath the bottom plate of the smokebox, about 1½" above the valve chest casting. (See Fig 3).

Fig 3. the plate over laying the valve chests. The cut off stud near the front shows the problem. These studs are firmly rusted into their threaded holes.

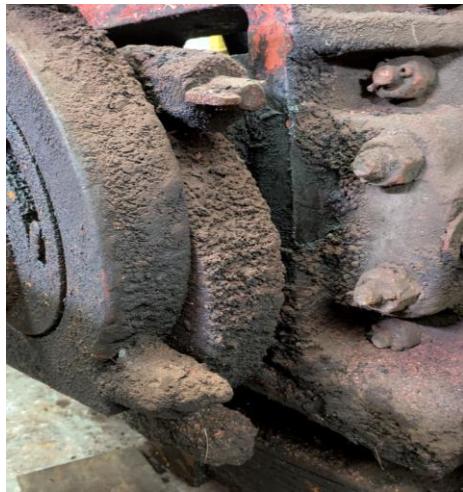
Fig 4. This shows the two right hand eccentric straps with the horn behind that is bolted to the frames.

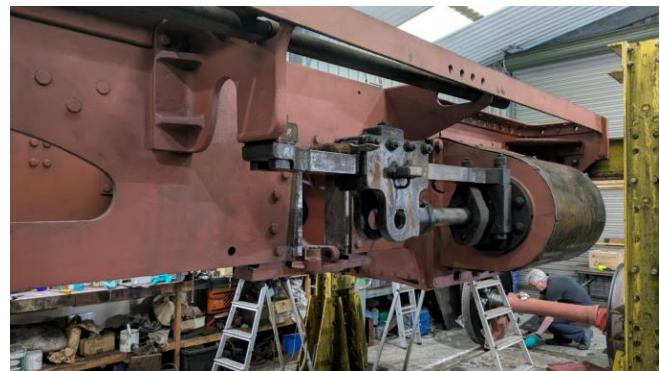
A major part of the work at this stage is removing great thick coverings of congealed grease, oil, ash and coal dust mix off of all of the parts prior to finding what fastenings one was dealing with. The whole of the mainframes were also similarly covered, often requiring burning or melting off before finishing by scraping and finally needle gunning. All of the frames both inside and out have now been needle gunned and painted in red oxide primer. As before the great majority of the work in dis-assembling, and needle gunning has been carried out by Melvyn Frohnsdorff. (See Fig4 & 5)

Fig 5. The frames now cleaned, needle gunned and in primer.

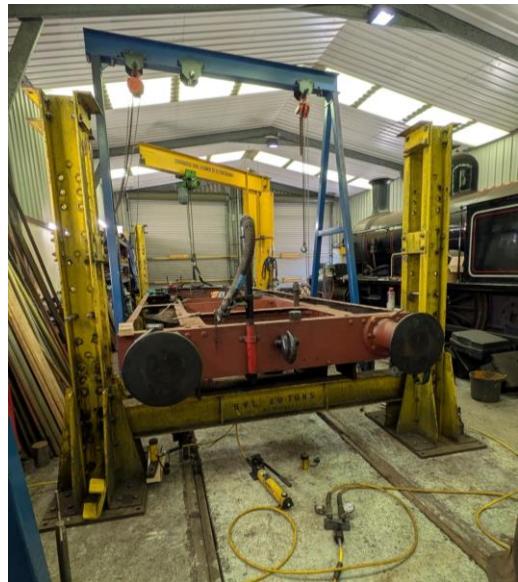
The lifting frames made for the Atlantic were renovated where necessary. So once we had finished with the chassis on its wheels the time came to lift it leaving the wheels on the ground. (See Fig 6)

Fig 6. The lifting beams in place under the frames ready for lifting.

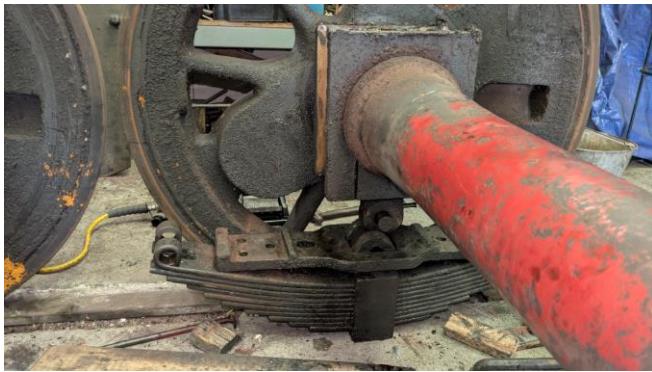
Getting to this stage though took a lot of effort as most of the taper pins and the spring suspension pins were firmly held in place by corrosion and lots of various contaminants mentioned above. Again lots of heat from the oxy acetylene torch was required to loosen most of these parts followed by drifting out the part with suitable sizes of punch. (See Fig 7)

Fig 7. The horn stay on top of the spring and the axle passing through the axlebox.

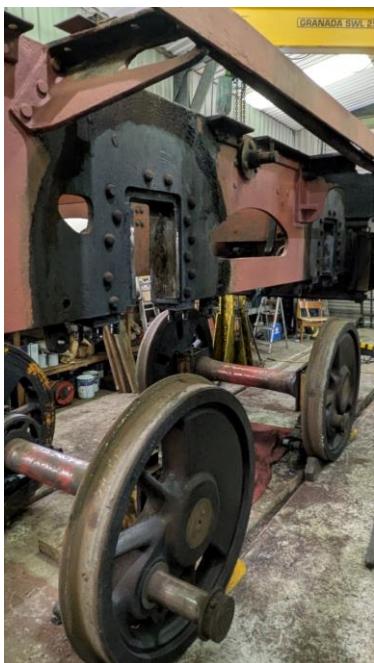
Once all the springs had been lowered off of the hangers and the horn stays removed we could raise the chassis using the lifting frames and leave the wheels with their axleboxes on the rails. At this time we could really see the state of filth that the wheels and axleboxes were in and of course likewise the frame faces behind them. (See Fig 8).

Fig 8. The frames now lifted, the wheels still on the rails. Note the dirt behind the area previously made inaccessible by the wheels.

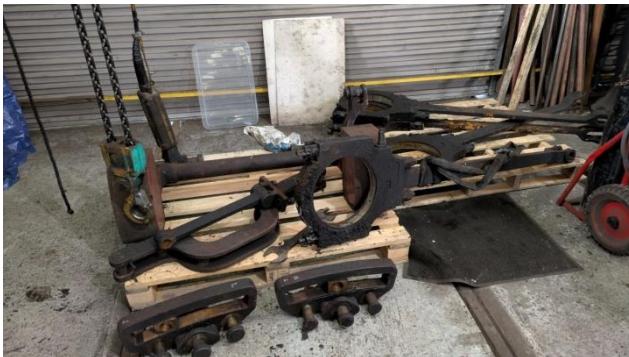
A review of some of the valve gear parts and their condition, which in general was not too bad with some exceptions showed the eccentrics sheaves when compared dimensionally with the eccentrics on the axle were useable as they are. The clearances are within tolerance and wear relatively light and once again though cleaning was necessary.

Fig 9. Valve gear parts removed, in the foreground the Expansion links, the omega shaped part is an intermediate valve rod that dodges over the leading axle, and eccentric straps and rods behind.

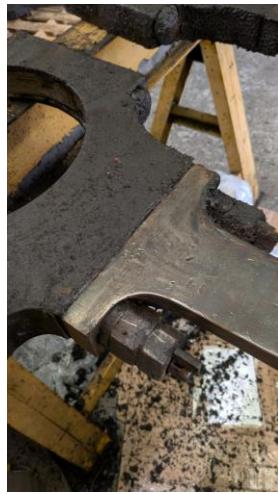
Fig 10 To the left is the dirty eccentric strap as removed and, on the right, the cleaned version.

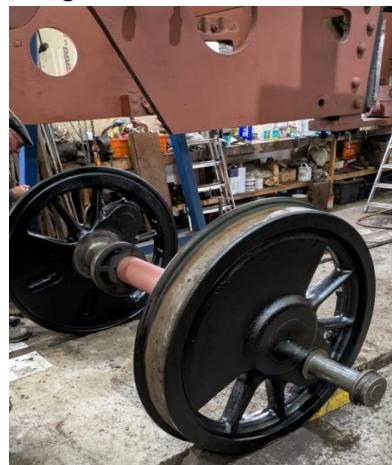
Fig 10. The cleaned wheels in black undercoat.

painted in primer and two coats of undercoat. (See Fig 12)

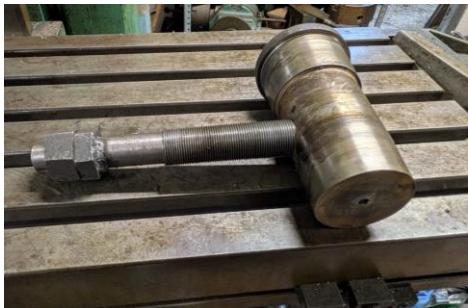
The piston and crosshead required separation. Again this is a self locking taper, but much larger. We have a hydraulic splitter to separate these parts used on all the BR standard locos plus lots of others, The B4 crosshead is too small to accept the BR standard hydraulic splitter, so again something new had to be made. A dummy gudgeon pin was machined from good quality steel, a hole was drilled then bored prior to tapping a hole right through it. We decided on 7/8" BSP as being a good size but with a fine enough thread yet robust enough to take a screw that will be tightened to its limit (or ours to be truthful!). (See Fig 13).

Fig 11. The dummy gudgeon pin with the fine pitched screw used to apply pressure onto the piston rod.

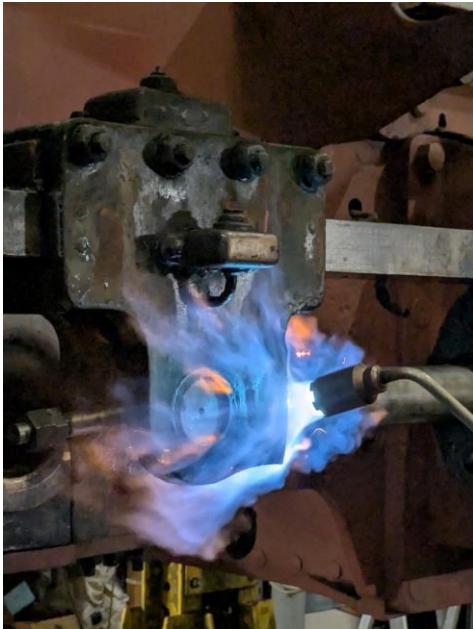
The dummy gudgeon pin fits through the crosshead replacing the original one, then the screw is threaded through it. The front end of the screw has a centre drilled hole in it as has the piston rod. When nearly in contact a hardened steel ball is positioned so in both the centre drilled holes in the screw and piston rod. The idea is that the ball helps prevent the end of the screw expanding under the pressure being exerted on it by the over tightening. Even with a length of pipe over a spanner no sign of splitting occurred so while under load the part of the crosshead with the piston rod taper in it was heated as quickly as possible using a large oxy propane torch. The crosshead should then expand slightly and its grip removed, and this is what happened to both sides. (See Fig 14 & 15).

Fig 12. The crosshead here is being heated to expand it while force was being applied to the piston rod.

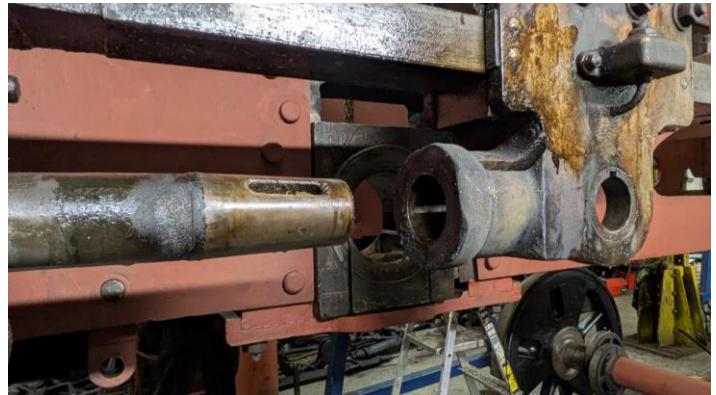
Fig 13. Here you can see the taper on the piston rod that fits into a matching one in the crosshead. Also the slots in both items that take the key that retain the parts in case of shock loadings such as water trapped in the cylinders.

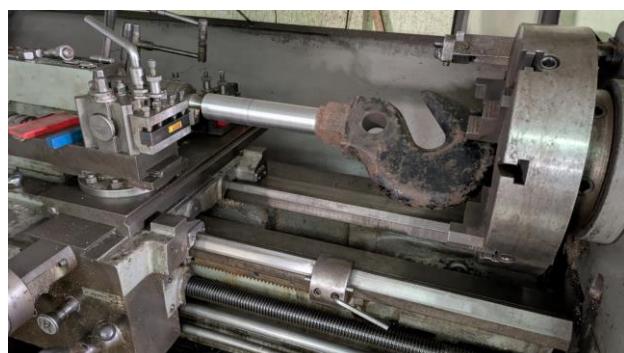
**Fig 15. Shortened coupling hook ready for screw cutting**

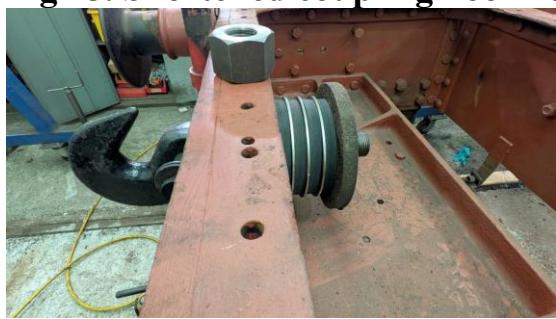
**Fig 16. Reworked coupling hook being trial fitted.**

New nut can be seen on top of the framing.

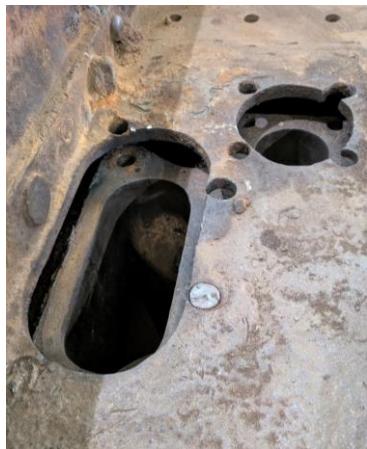
Fig 17. the plate over laying the valve chests. The cut off stud near the front shows the problem. Bear in mind these studs are firmly rusted into their threaded holes.

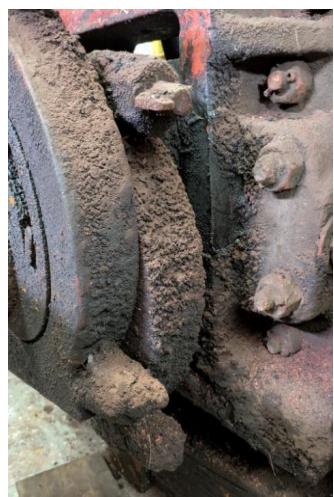
Fig 18. This shows the two right hand eccentric straps with the horn behind that is bolted to the frames. In as received condition!

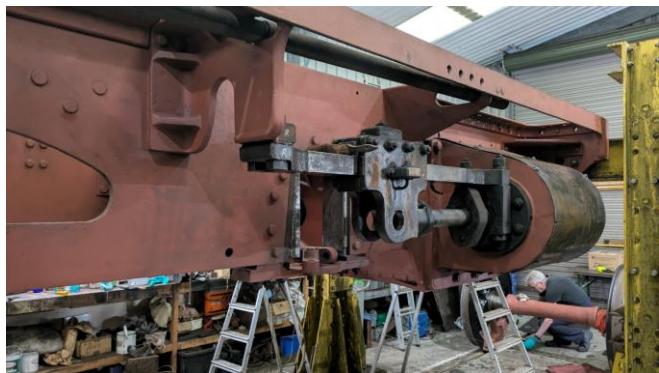
Fig 19. The frames now cleaned, needle gunned and in primer.

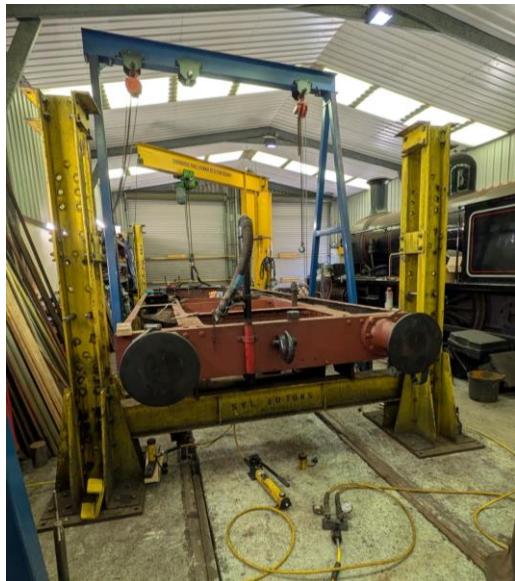
Fig 20. The lifting beams in place under the frames ready for lifting.

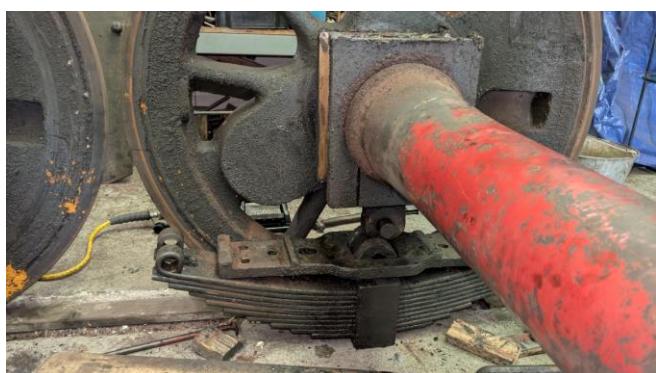
Fig 21. The horn stay on top of the spring and the axle passing through the axlebox.

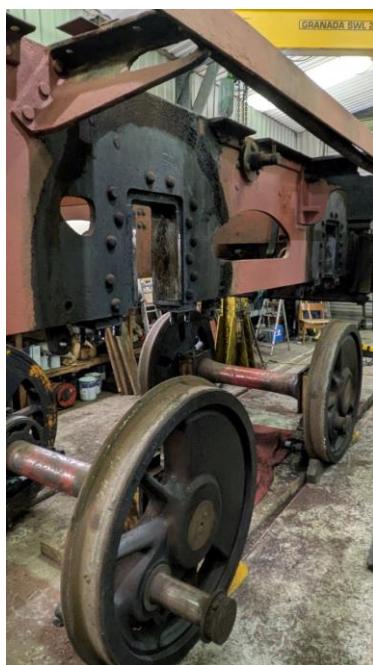
Fig 22. The frames now lifted, the wheels

still on the rails. Note the dirt behind the area previously made inaccessible by the wheels.

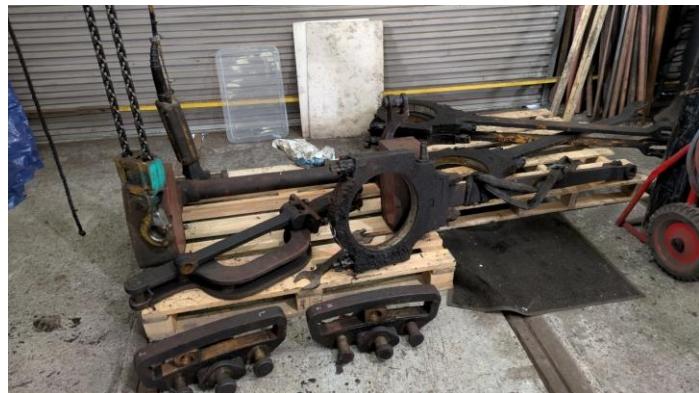
Fig 23. Valve gear parts removed, in the foreground the expansion links, the omega shaped part is an intermediate valve rod that dodges over the leading axle, and eccentric straps and rods behind.

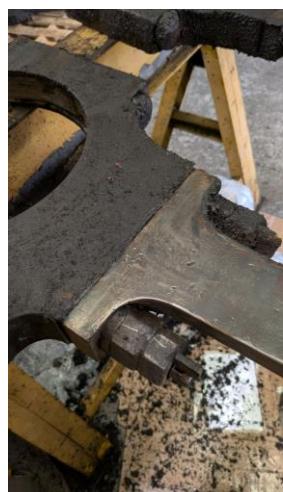
Fig 24. To the left is the dirty eccentric strap as taken off of the engine, the rod to the right has been cleaned.

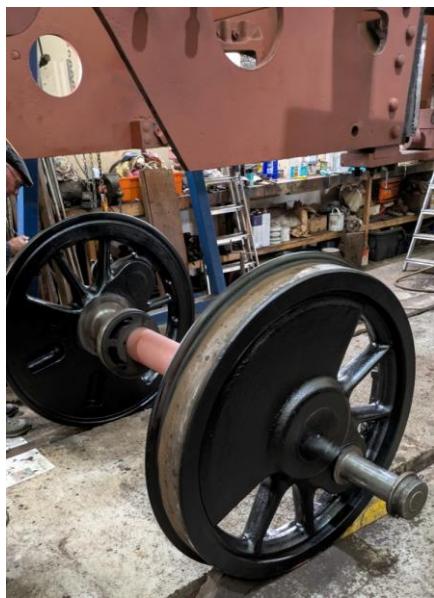
Fig 25. The cleaned wheels in black undercoat.

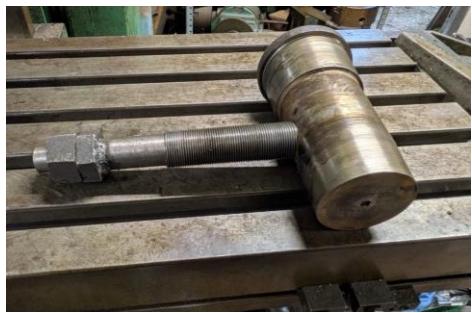
Fig 26. The dummy gudgeon pin with the fine pitched screw used to apply pressure onto the piston rod.

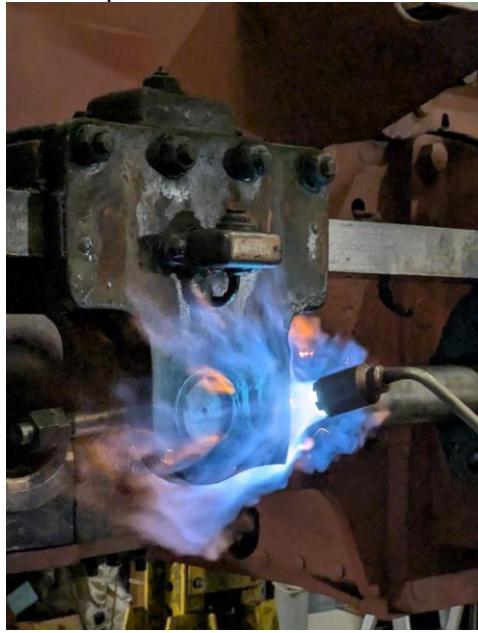
Fig 27. The crosshead here is being heated to expand it while force was being applied to the piston rod. Note: we spotted the screw was not correctly positioned and it was rectified prior to continuing.

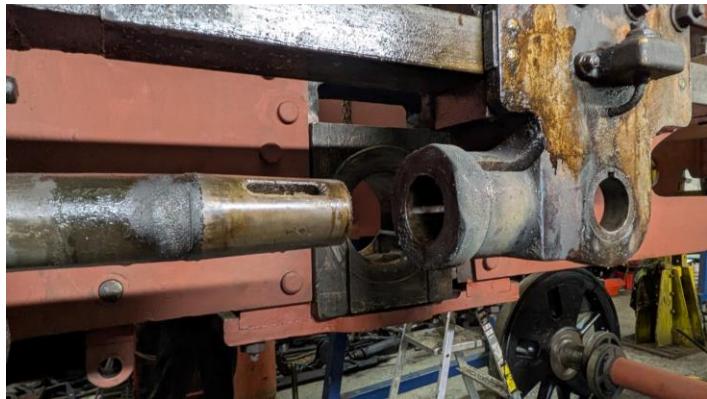
Fig 28. Here you can see the taper on the piston rod that fits into a matching one in the crosshead. Also the slots in both items that take the key that retain the parts in case of shock loadings . For example water trapped in the cylinders.

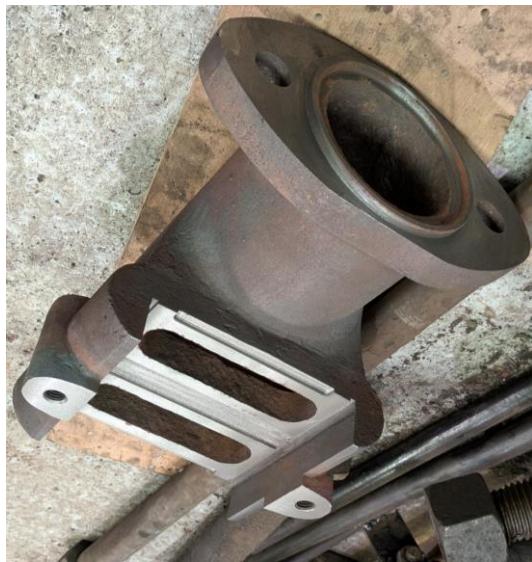
Just to prove something productive has happened here is a photograph of the original regulator casting now fully re-machined in our main works, ready for installation-- eventually! (See Fig 16)

Fig 29. Here is the re-machined regulator body.  
When will this be installed!
